Greenpeace Research Laboratories Analytical Results 2023-04

Microplastic fibres and fragments in nearshore surface waters of 7 lakes in Austria in May and June 2023

David Santillo, August 2023, 19 pp.

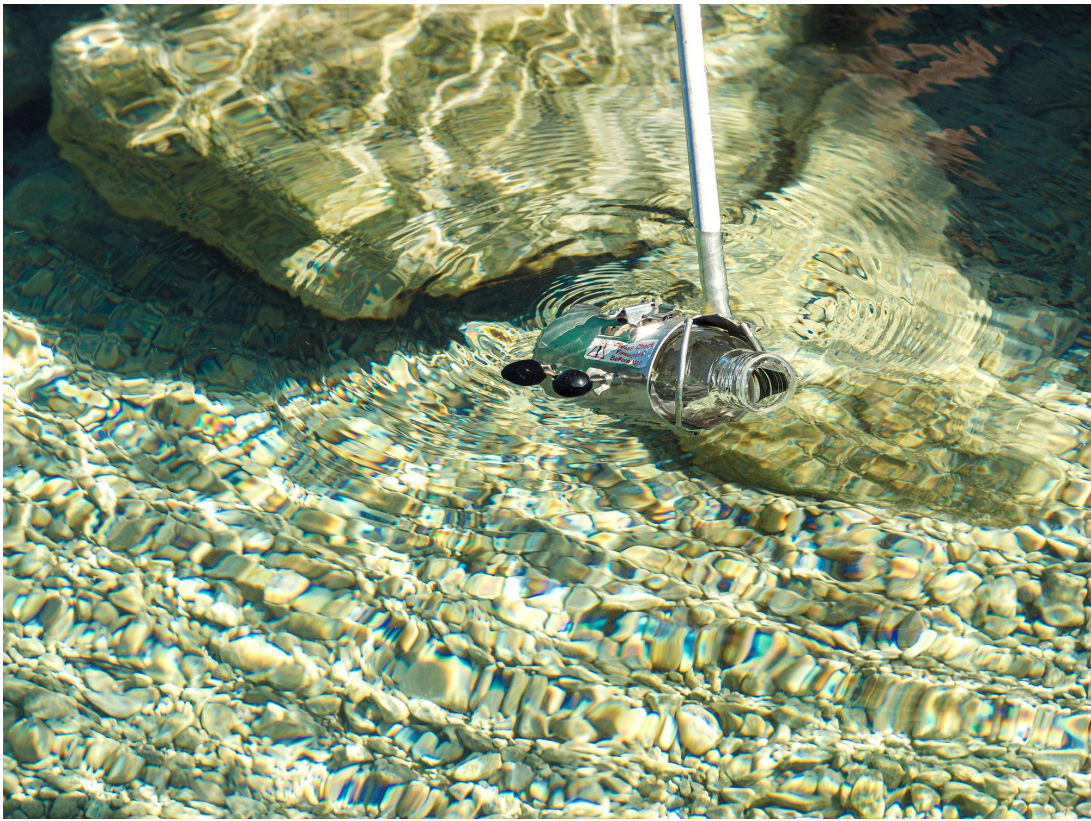
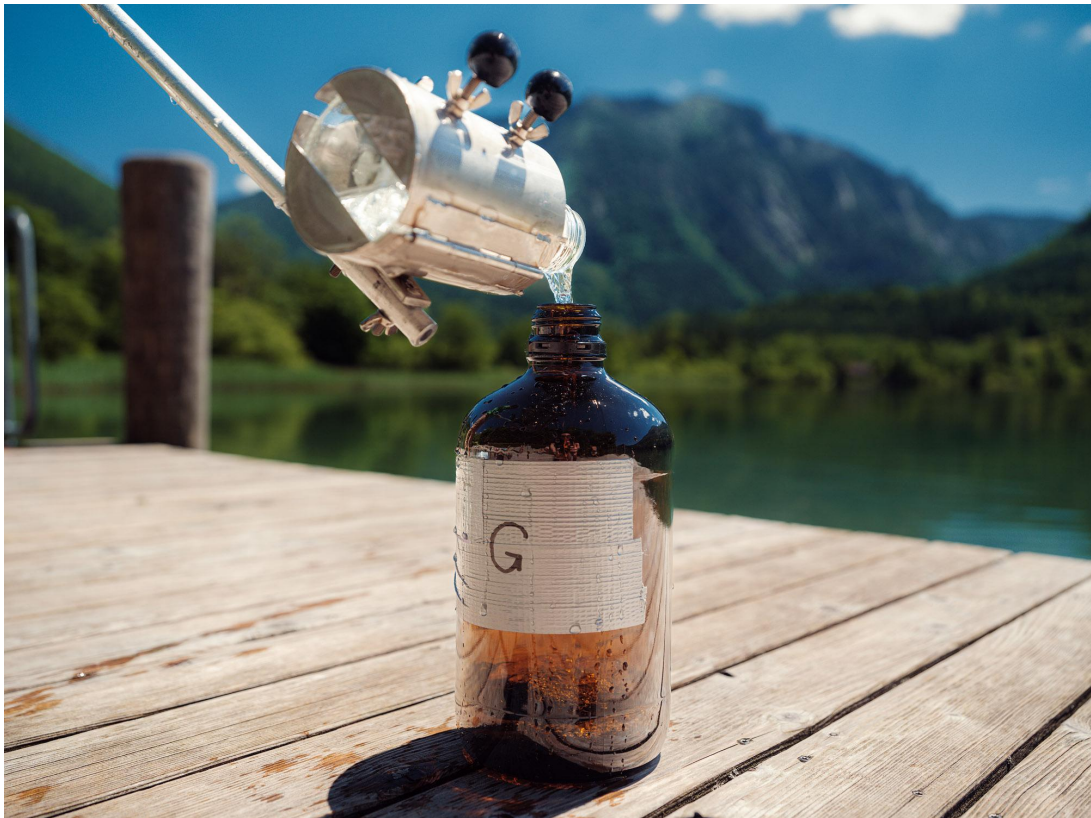
Figure 2: sampling equipment used, showing sample pole, 500ml sampling bottle and 2.9 litre composite sample container (Winchester)

Each sample was collected as a composite of 5 separate fills of a 500ml (nominal volume) bottle, held at the end of a stainless steel sampling pole. The bottle was rinsed three times in the lake water before collecting the first portion. The 5 portions were combined into a single composite sample per site in an amber glass Winchester bottle of approximately 2.9 litre volume (which had been pre-cleaned in our laboratory by rinsing 3 times with 200ml deionised water prefiltered through a 5µm silver filter). In each case, the 5 separate portions were collected within a radius of about 10m from each other and at a depth of between 10-20 cm. The outer surfaces of the Winchester bottles were rinsed with lake water on arrival at each site before removing the lid to collect or transfer the sample, to prevent ingress of dust from the outer surfaces of the bottles. Sampling equipment is illustrated in use in Figure 2.
